Inspection Report

Property Address:
1234 Main Street
My Town, Pa. 00000

Accredited Home Inspections, L.L.C.

Date: 5/5/2007	Time: 5:11 PM	Report ID: Jones Insp., May 7-07.
Property: 1234 Main Street My Town, Pa. 00000	Customer: Mr. John Jones	Real Estate Professional: James Jones Robin Kemmerer and Associates

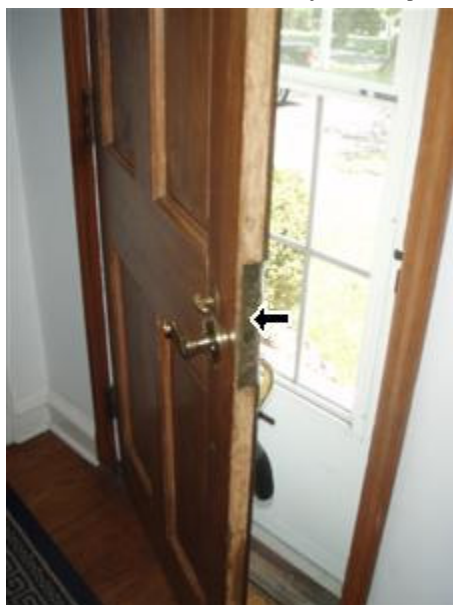
2.1 Picture 1 repair lock

2.1 The front door lock should be adjusted or replaced so it operates properly

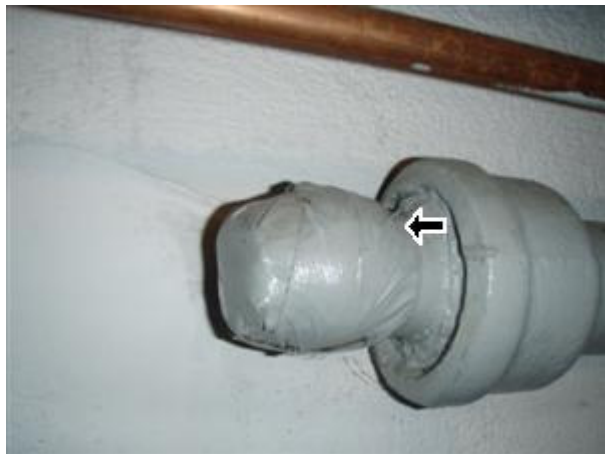
4.0 Picture 1 properly seal

4.0 There is a cast iron pipe in the basement that is sealed with duct tape. This should be properly sealed. Also, the upstairs bathtub is slow to drain. In addition, the toilet is loose in the upstairs hall bath. Finally, the vent stack for the drain line outside the house is missing a cover. These items should be addressed.

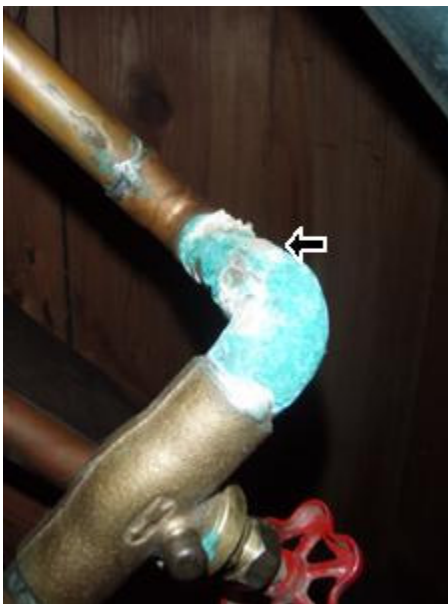
4.2 Picture 1 clean pipe

4.2 There is heavy corrosion on a water pipe in the basement. It should be cleaned and checked for leaks. If leaking, it should be repaired. We also noticed what appeared to be dirt coming from the water lines into the tub (see picture) and into the sinks. The water company may have been flushing the line, but we recommend this be checked to determine the source of the dirt.

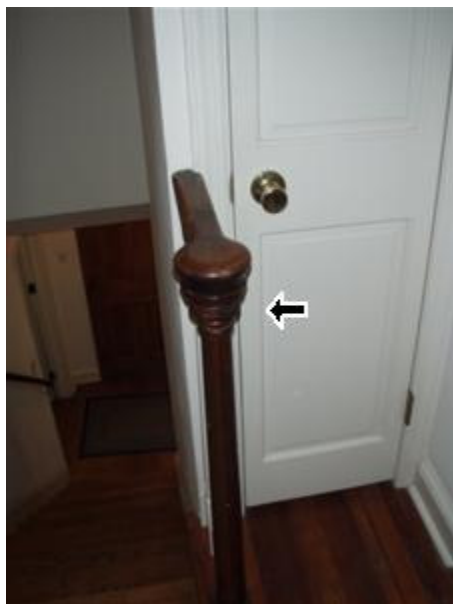
8.3 Picture 1 tighten rail

8.3 The rail at the top of the stairs is loose and should be tightened. also, we recommend a rail for the steps into the room over the garage.

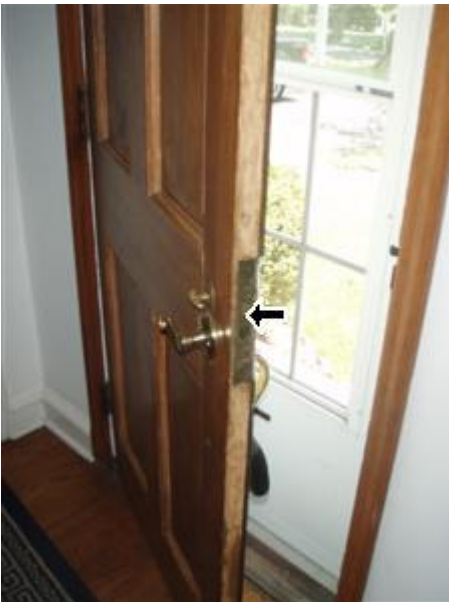
2.1 Picture 1 repair lock

The front door lock should be adjusted or replaced so it operates properly

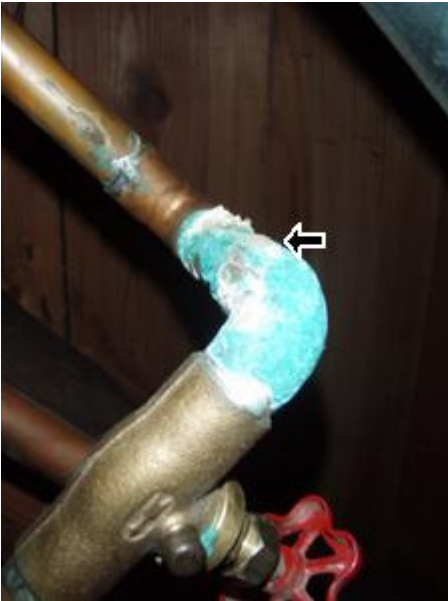
4.2 Picture 1 clean pipe

There is heavy corrosion on a water pipe in the basement. It should be cleaned and checked for leaks. If leaking, it should be repaired. We also noticed what appeared to be dirt coming from the water lines into the tub (see picture) and into the sinks. The water company may have been flushing the line, but we recommend this be checked to determine the source of the dirt.

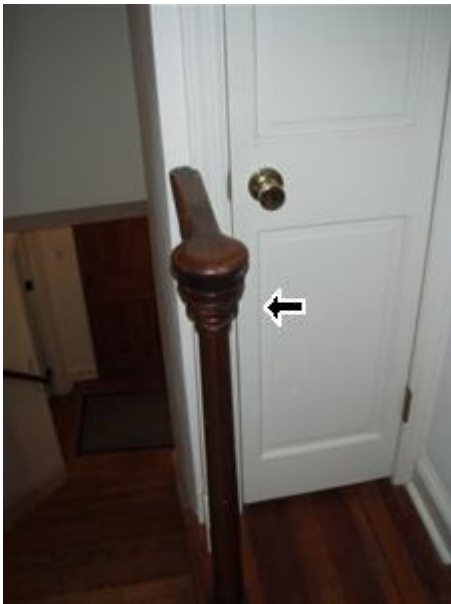
8.3 Picture 1 tighten rail

The rail at the top of the stairs is loose and should be tightened. also, we recommend a rail for the steps into the room over the garage.
